# Gatley Hill evaluation April 2017

South Manchester Archaeological Research Team working with Norman Redhead and Cheadle & Gatley U3A Archaeological Group were asked to carry out test pitting on the site of the 16<sup>th</sup> century farm buildings highlighted in the painting above. Whilst this image does show an element of artistic licence, does indicate the possible locations and structure of the original buildings. This was to establish the level of archaeological remains of these buildings, with a view to submitting an application for funding to carry out a community excavation adjacent to Scholes Park. The evaluation took place over two days in April 2017 and further work is scheduled for March 2018 where it will be necessary to encroach the boundary of Scholes Park where with reference to OS maps there is evidence of the three additional farm buildings associated to the initial dig which was set to reveal the barn/warehouse as seen in (Fig 1). This building was established as the best initial excavation option due to its accessibility and proximity to the adjacent car park. This would cause little disruption to the Scholes Park public visitors and was the most open space o

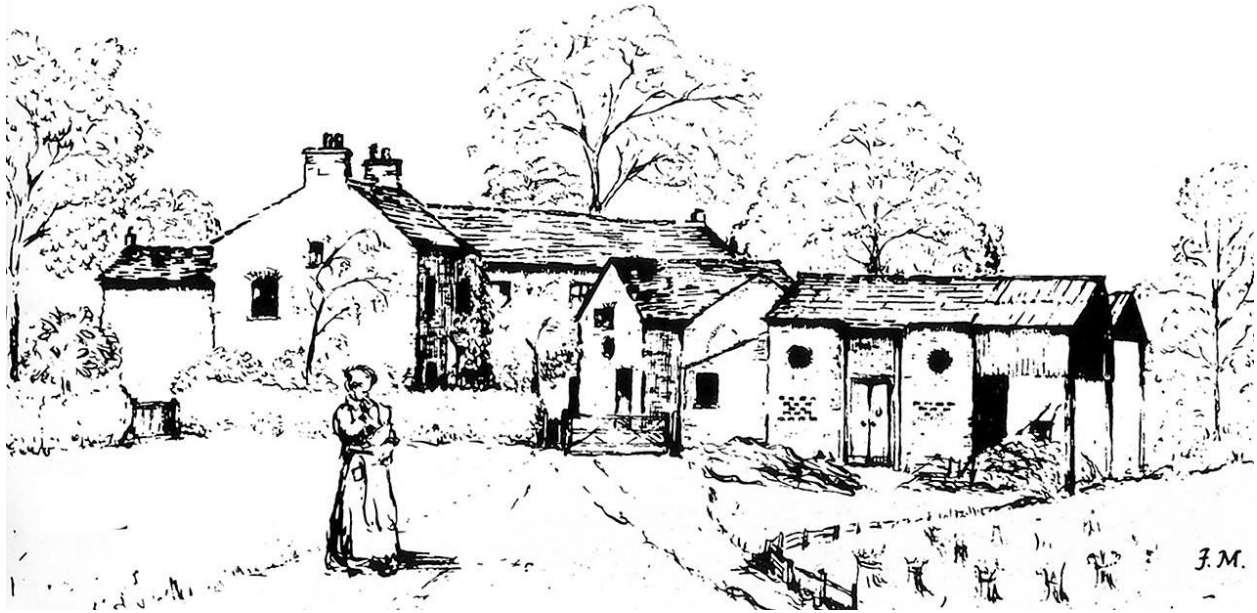
(Mitchell & Mitchell 1980, 15)

Drawing of Gatley Hill Farm by Frank Mitchell from an original painting by Peter Burrows

A painting of Gatley Hill Farm shows several buildings which include a two-storey farmhouse and a barn, but it is difficult to relate these various structures to the historical mapping.

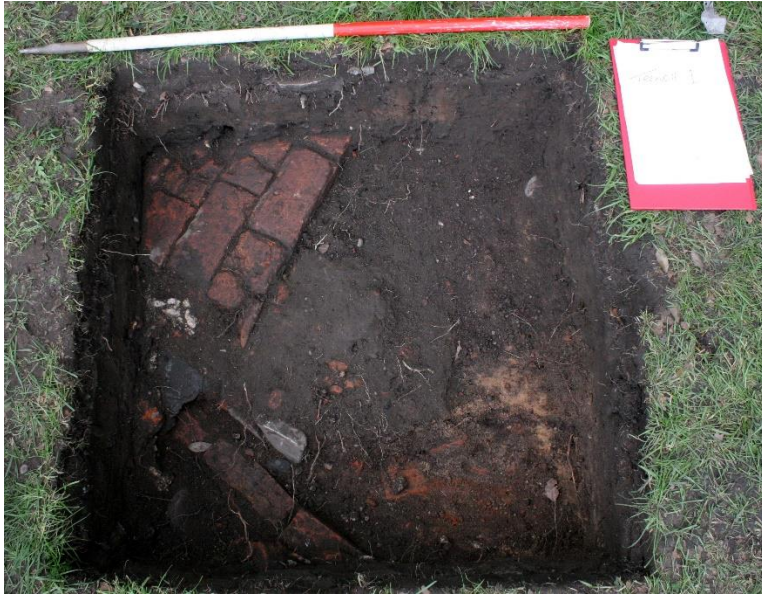
This trench was located central to the site with a view to establishing wall features of the warehouse structure and possible internal wall features. The conclusions were internal wall structures possibly stalls. North west south east orientated wall three course brick feature

evident in the top left of the excavation, little evidence of bonding substantiating the probability this is an internal wall/floor feature as seen in (Fig 2)

Fig 2:- Showing north west, south east wall/floor surface with return. Trench 1

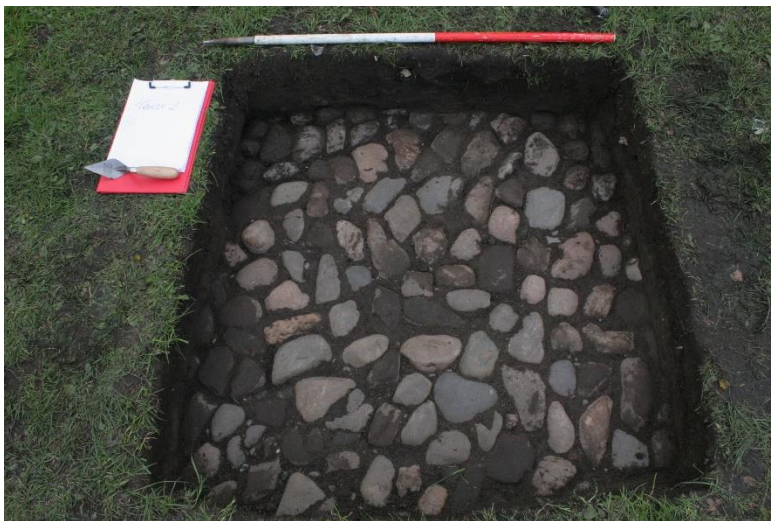
This trench revealed an external cobbled floor surface to the east of the main structure, cobbles were large and ovoid in shape measuring from 5cm x 3cm – 6cm x 8cm, evenly spaced and level for a solid floor surface see (Fig 3)

Fig 3:- Cobbled floor surface situated to the east of the main structure. Trench 2

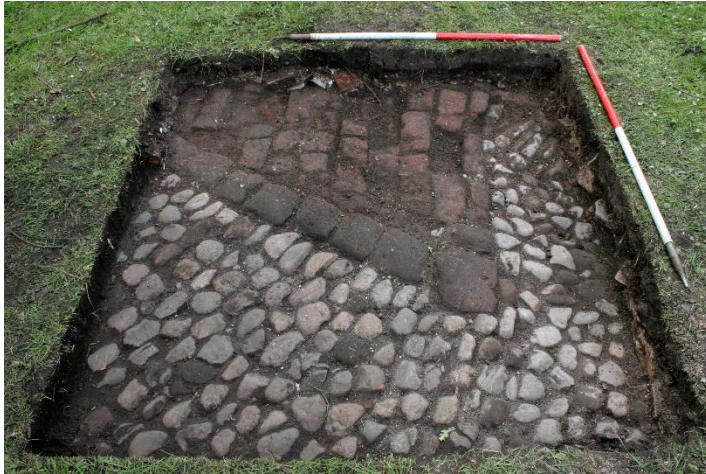
Located as were all trenches on the grassy area adjacent to the car park and located over the potential remains of the warehouse/barn structure of the old farm. This trench revealed evidence of a cobbled courtyard and stone sett kerbing for what we established was the courtyard to the south of the warehouse structure. The cobbles were ovoid in shape water washed and on average 10cm in length and 6cm in width. The sett size 6cm x 6cm, with handmade brick floor laid edge on 7cm x 21c. This trench was extended to 2m x 2m to allow further investigation of the relationship between the various surfaces found in the initial excavation Fig 4:-

Fig 4:- West facing image of trench 3 showing the cobbles and setts, with a brick floor surface to the south west edge. Trench 3

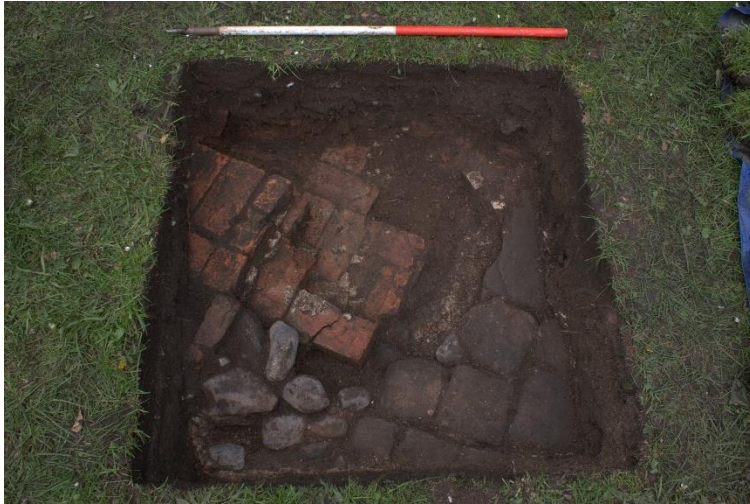
This trench was located to the north of the site and revealed the most significant archaeology in relation to the warehouse/barn. It was established that we had several levels of archaeology. The north east corner of the warehouse/barn was established. Also revealed were two external floor surfaces. These consisted of irregular cobbles ranging in size from 5cm x 5cm to 7cm x 6cm, laid adjacent to a stone sett floor 6cm x 6cm. (Fig 5)

Fig 5:- Cobbled external floor surface adjacent to stone sett's with the north east return of the main warehouse/barn feature trench 4

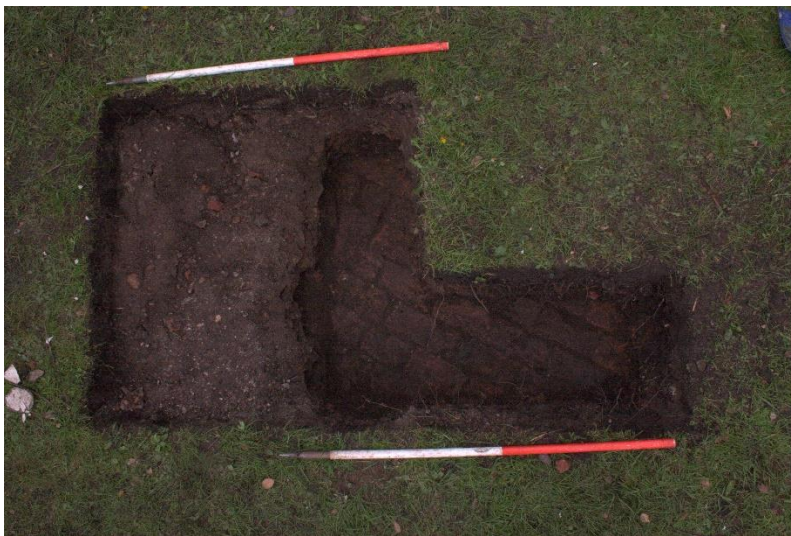
This trench revealed an internal brick herring bone laid floor surface located centrally and to the east of the main structure. There wasn't any bonding evidence found, and they were laid south west, north east in relation to the main building. They were consistent and well laid providing a quality surface. Bricks measured 20cm x 7cm no depth measurement was available. (Fig 6)

Fig 6:- herring bone laid internal floor surface laid north east- south west

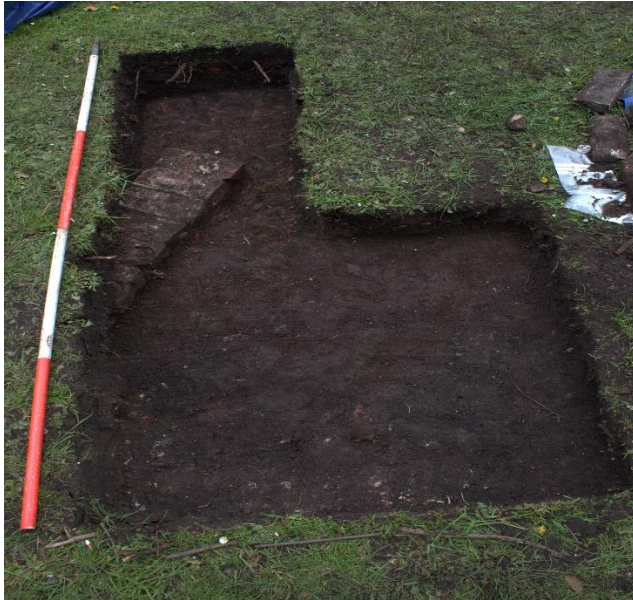
This trench revealed a single course external brick wall, which was established was likely to be an outhouse/lean-to structure with little evidence of any bonding and was a later extension to the main building, located to the east side of the main structure. (Fig 7)

Fig 7:- single course external brick wall, probable lean-to structure constructed to the east of the main building
